DE LOREAN MOTOR COMPANY

# SERVICE BULLETIN

NUMBER SC-01-11/81

SUBJECT: SAFETY CAMPAIGN NO. RA-0001 (RECALL)  
BALL JOINTS - STABILIZER BAR MOUNTINGS - V.I.N. 560 - 6650\*

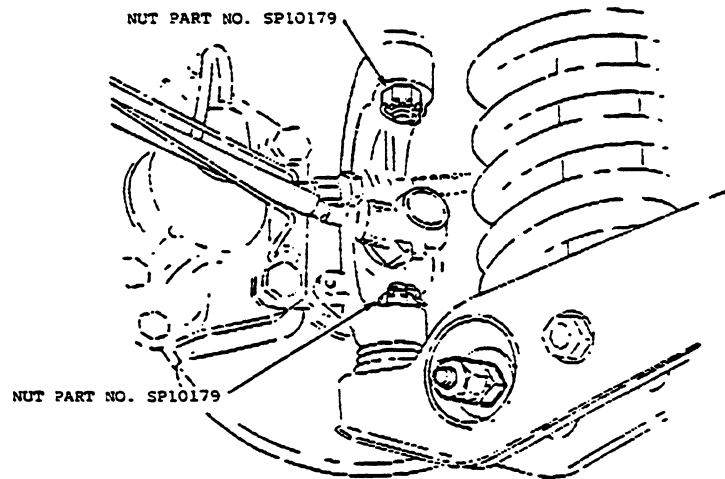
FIGURE 1

- A. The stabilizer bar is attached to the lower links and secured by a nut at each end. These nuts may loosen, causing partial or complete detachment of the stabilizer bar from the lower link assemblies. The forward mounting brackets for the stabilizer will be serviced at the same time.
- B. Each lower ball joint is mounted through the lower link and steering knuckles and secured by a nut. These nuts may loosen, causing partial or complete detachment of the ball joints. The upper ball joints will be serviced at the same time.

4. Remove left-hand existing ball joint upper and lower retaining nuts and discard.

5. Install castellated nuts Part No. SP 10179 to upper and lower ball joint. Torque to 50NM (37 ft/lbs.)
6. Using slots in nuts as a guide, drill 3.3mm hole through the ball joint's threaded studs.
7. Remove metal shavings.
8. Insert split pins Part No. SP 10340 3mm x 26mm. Bend the pin ends - lower portion over nut and top portion over ball joint thread.
9. Repeat procedure for right-hand side upper and lower ball joints.

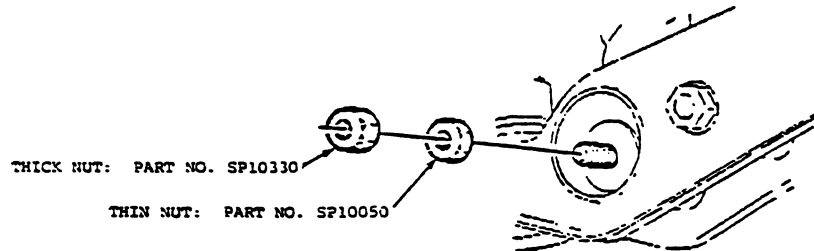
FIGURE 3

De Lorean Motor Company has determined that a defect which relates to motor vehicle safety exists in the front suspension of 1981 De Lorean vehicles. The nuts fastening the stabilizer bar to the lower link and the lower ball joints to the lower link may become loose, possibly resulting in detachment of the stabilizer bar or lower ball joints.

1. Remove existing nylock nut and discard.
2. Clean stabilizer bar threads.
3. Coat stabilizer bar threads with Stud-N-Bearing Mount Loctite or Stud-N-Bearing Mount Permatex. Install thin nut Part No. SP 10050 and torque to 60NM (44 ft/lbs).
4. Recoat remainder of the thread with Stud-N-Bearing Mount Loctite or Stud-N-Bearing Mount Permatex and install thick nut Part No. SP 10330 and torque to 90NM (68 ft/lbs). When performing Step 4, ensure that the thin nut doesn't rotate.
5. With red paint, color code all areas of rework: top and bottom ball joints, right and left-hand front stabilizer bar mountings, rear stabilizer bar mountings.
6. Lower hoist to waist level, mount road wheels and torque to specification 80NM (59 ft/lbs).
