DE LOREAN MOTOR COMPANY

# SERVICE BULLETIN

NUMBER SC-03-1/82

SUBJECT: SAFETY RECALL NOTICE SUPPLEMENT  
SAFETY CAMPAIGN # RA-0001 (RECALL)  
BALL JOINTS - STABILIZER BAR MOUNTINGS  
V.I.N. 560 - V.I.N. 7199

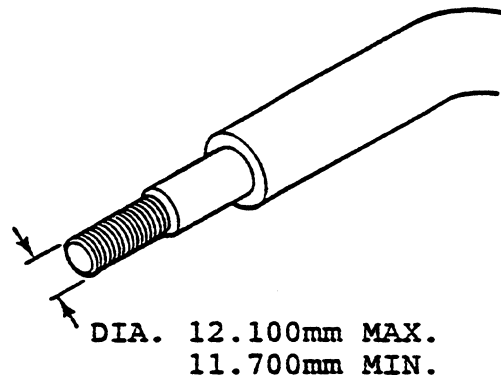
FIGURE 1

11. With a micrometer, measure the outside diameter of the threaded end studs on the stabilizer bar (Figure 1). Reading must be 12.1 mm (.476 inch) maximum to 11.7 mm (.460 inch) minimum.

NOTE: If the reading is below 11.7 mm (.460 inch) replace the stabilizer bar with new unit (P/N 100233).
