CATEGORY: TECHNICAL

SUBJECT: WIRING HARNESS ROUTING ON RIGHT (REAR) BULKHEAD PANEL

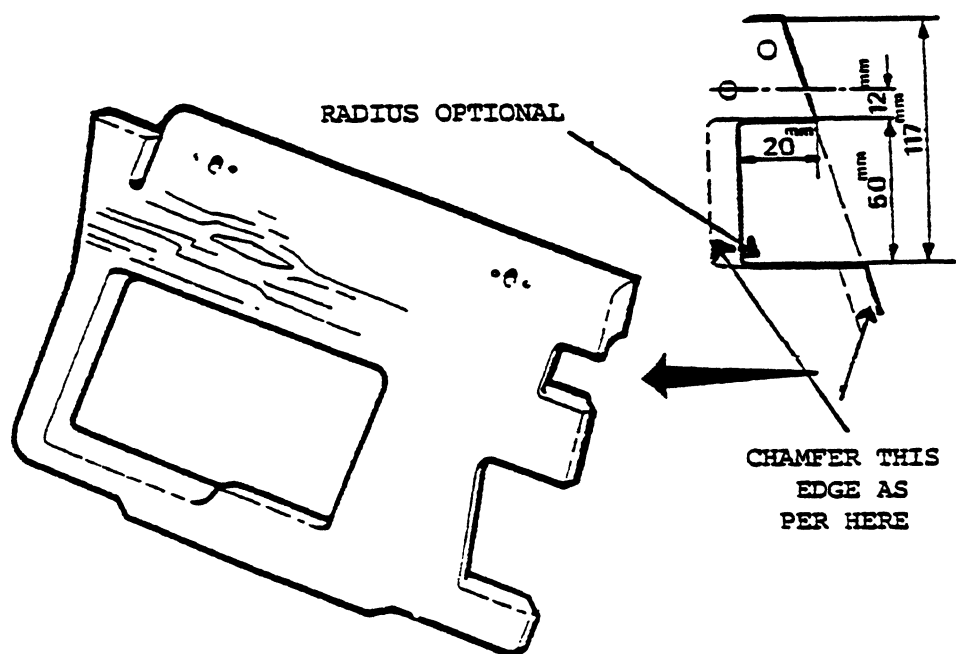
From V.I.N. 2309, a recess has been cut out of the right rear bulkhead panel to accommodate the wiring harness. See the diagram below.

This modification may also be made on earlier vehicles to improve harness routing.
