## DeLorean Owners Association Regional Chapter 41

April 3, 1997

### Fuel Delivery System

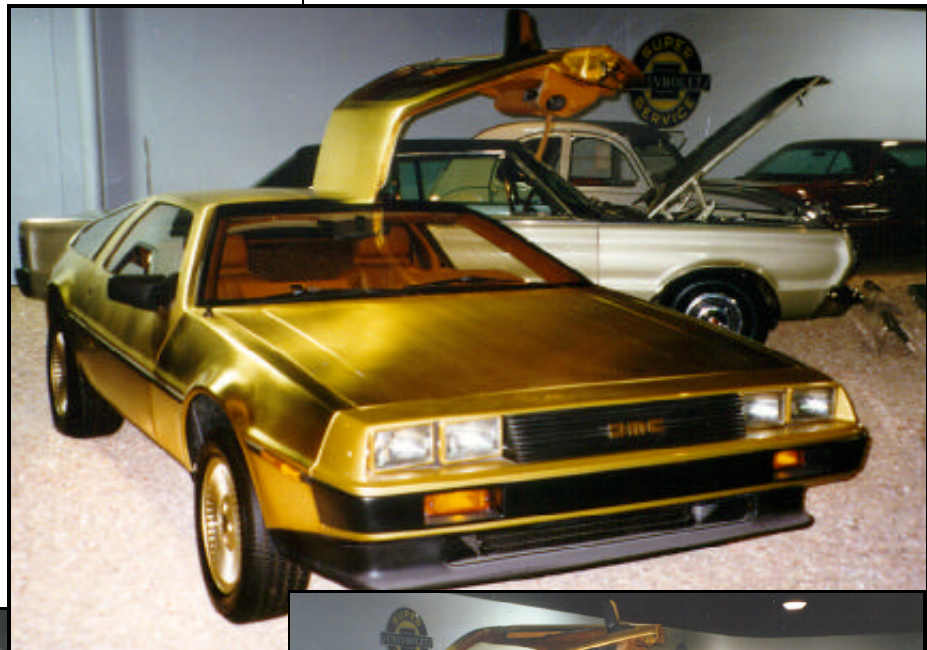
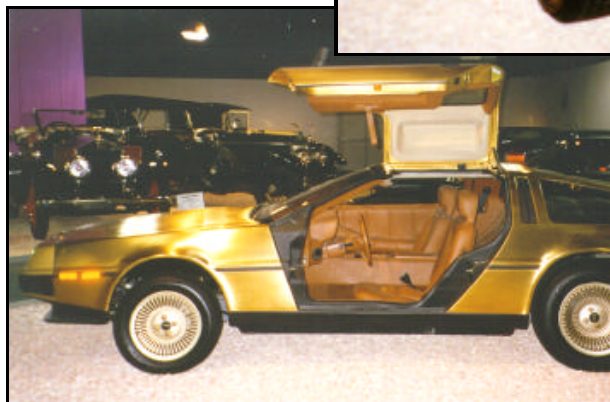
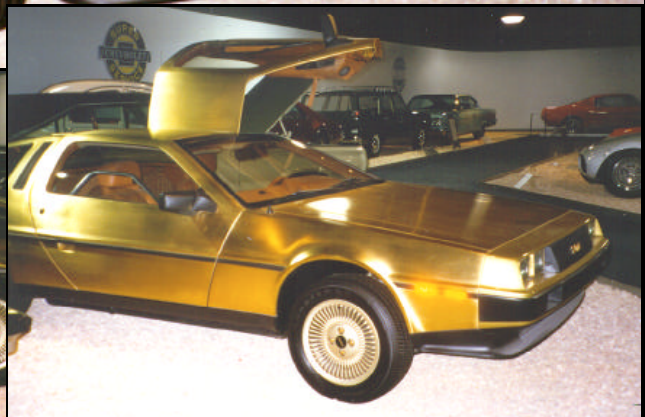
Only three gold-plated Deloreans were made. The 1981 car I saw in Reno has VIN number 4300 and 1,442 miles on the odometer. It features a 5-speed manual transmission and the “saddle” leather seats (see photos). According to the plaque, the car was donated to the museum by Sherwood Marshall for insurance reasons. The plaque indicated that the estimated cost to repair a single door was \$24,000. Some estimates place the value of the car in the neighborhood of \$175,000 (keep in mind that a “value” requires someone willing to buy it at that price).
