DE LOREAN MOTOR CARS OF AMERICA  
Division of DeLorean Motor Company

# SERVICE BULLETIN

NUMBER ST-06-9/82

CATEGORY: TECHNICAL  
ATTENTION: ALL DMC DEALERS/SERVICE MANAGERS  
SUBJECT: TEMPORARY WIRING MODIFICATION - FAN FAIL  
MODULE

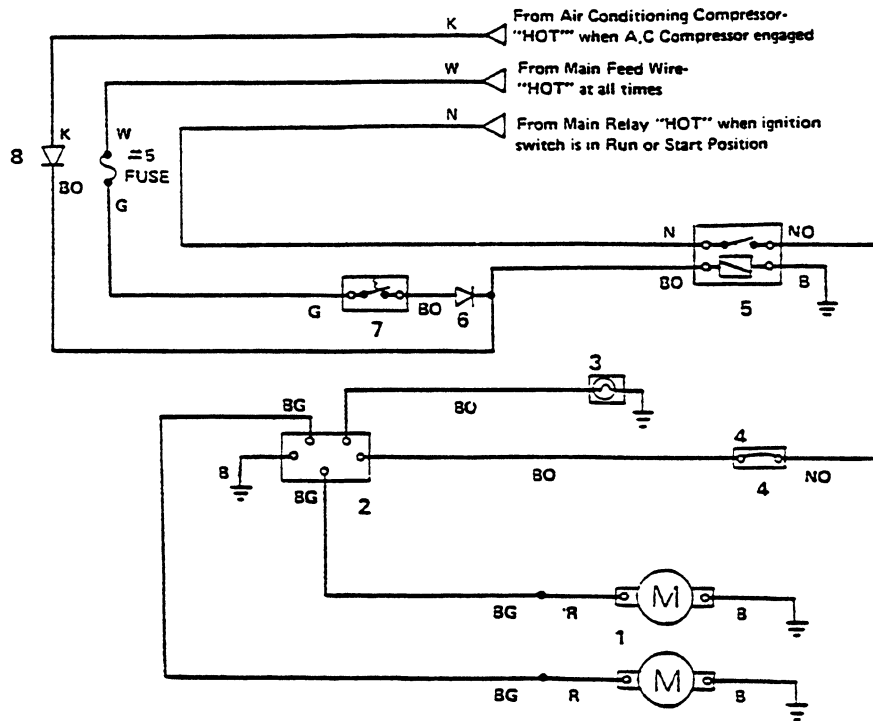
fig 1 COOLING FAN CIRCUIT

1 - Cooling Fans  
2 - Fan fail module  
3 - Fan fail warning lamp  
4 - Circuit breaker

5 - Fan relay  
6 - Cooling Fan Diode  
7 - Temperature switch  
8 - A,C Diode

It is important to positively determine that the fan fail module is defective prior to installing this link wire assembly. A check should be made on the cooling fans to ensure they have not seized. The entire engine cooling fan circuit and components must also be checked for continuity and operation with special attention to all connections (Figure 1).
